SPECIAL REPORT ON ANADROMOUS STREAM SURVEYS OF CLEVELAND
PENINSULA, INCLUDING EMERALD BAY, VIXEN INLET, UNION BAY,
CLARENCE STRAIT, BOND BAY, SPACIOUS BAY, AND PORTIONS OF
PORT STEWART AND HELM BAY

Subdistricts 101-90 and 101-80

Volume II

March 1985

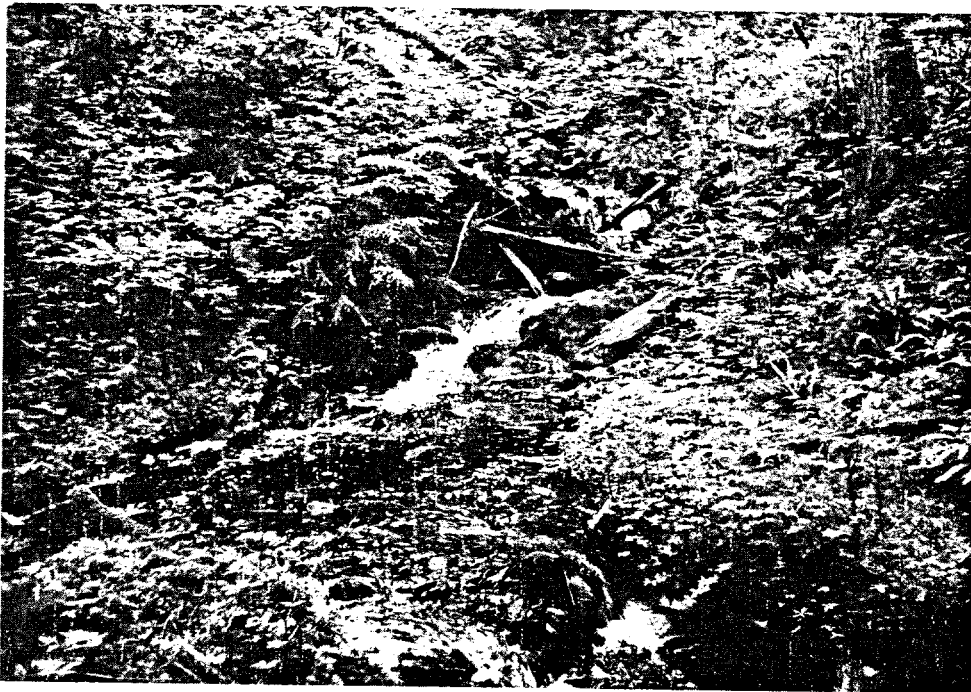
4. Probable block in Section #12.

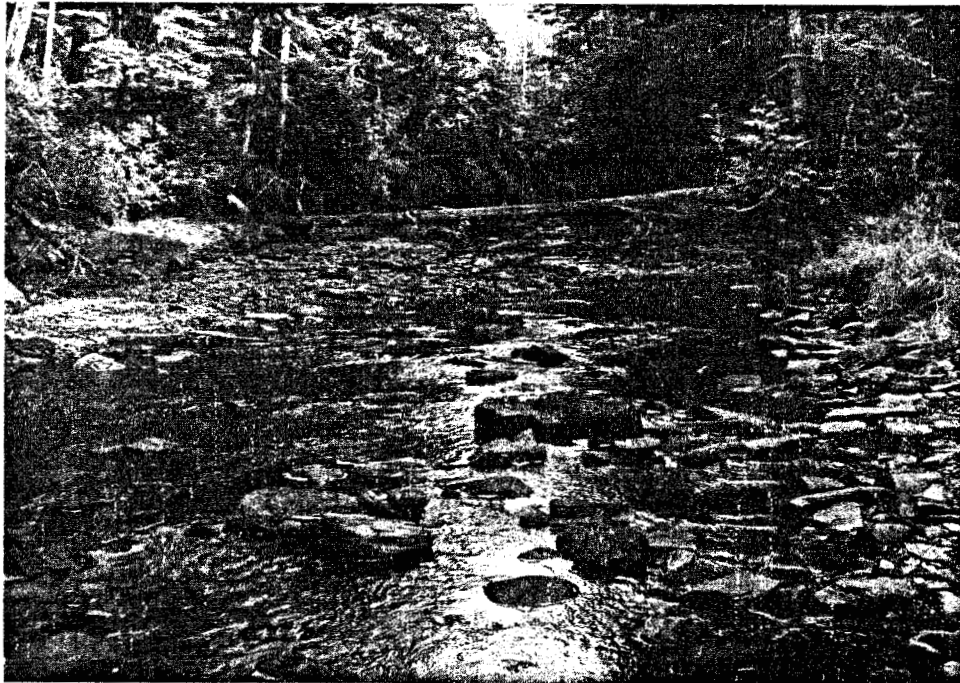
2. Section 1: Large substrate with little ASA

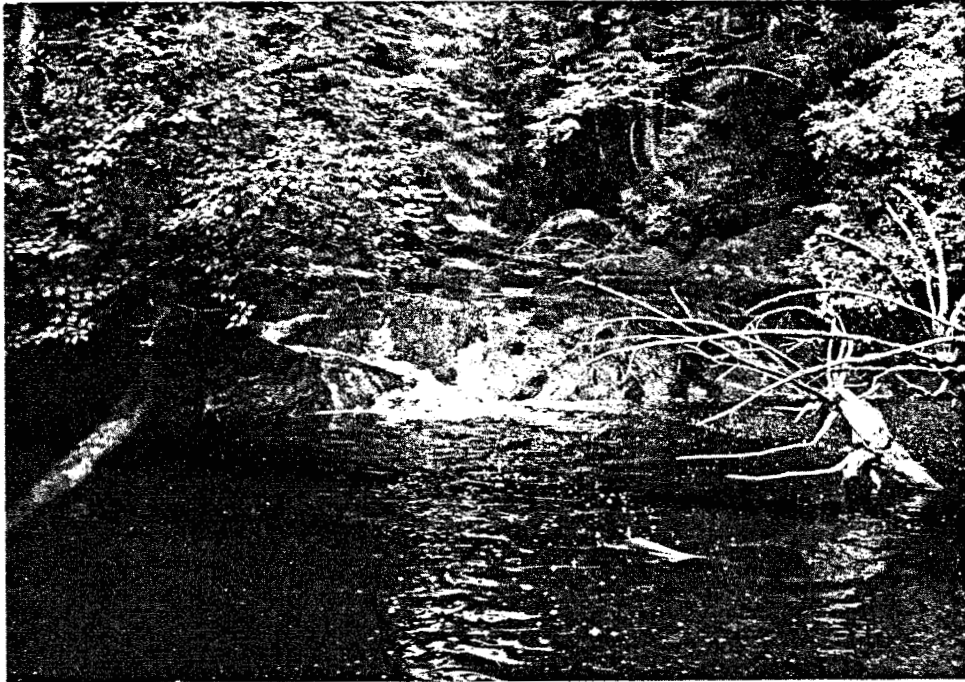
3. Section 2: Series of small falls
1.5 m. - not a barrier.

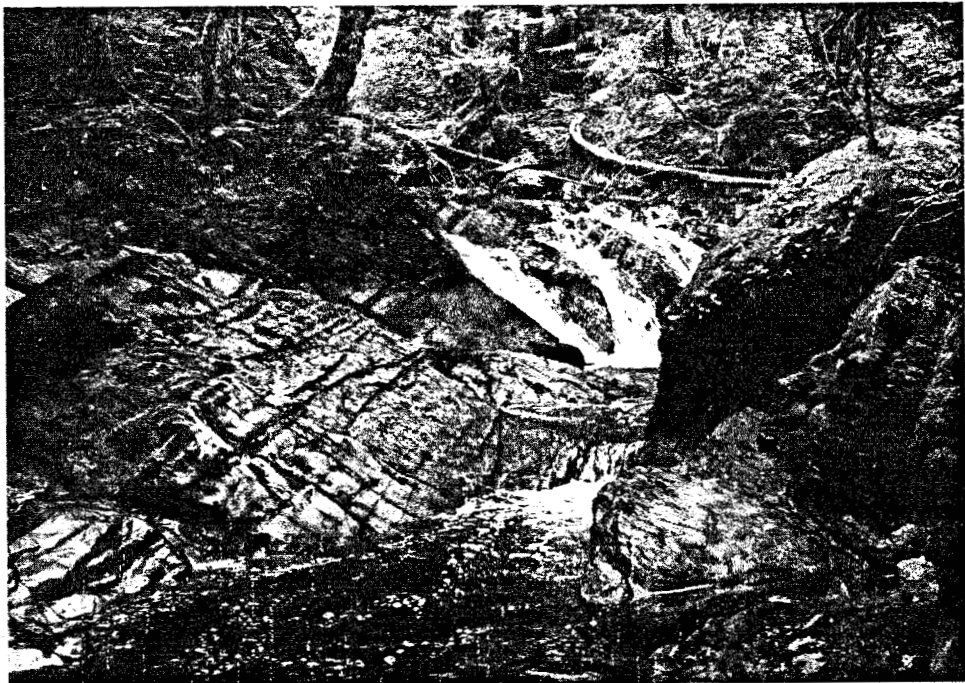
4. Section 3: 3 m. barrier falls 30 m. into
the Section.

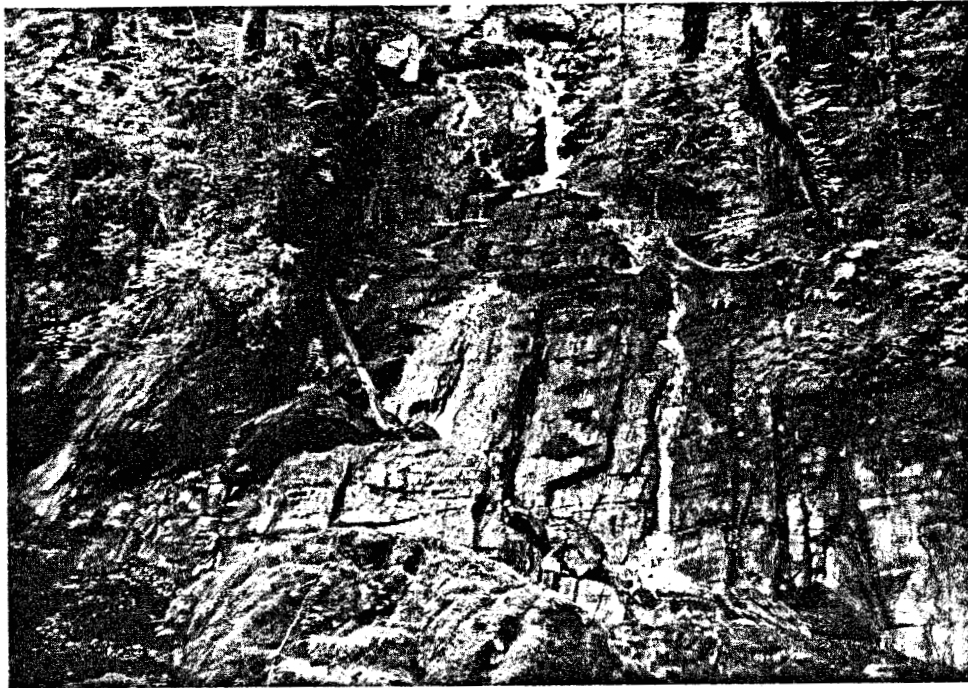
5. Section 3: Tributary entering from the left bank by the falls.

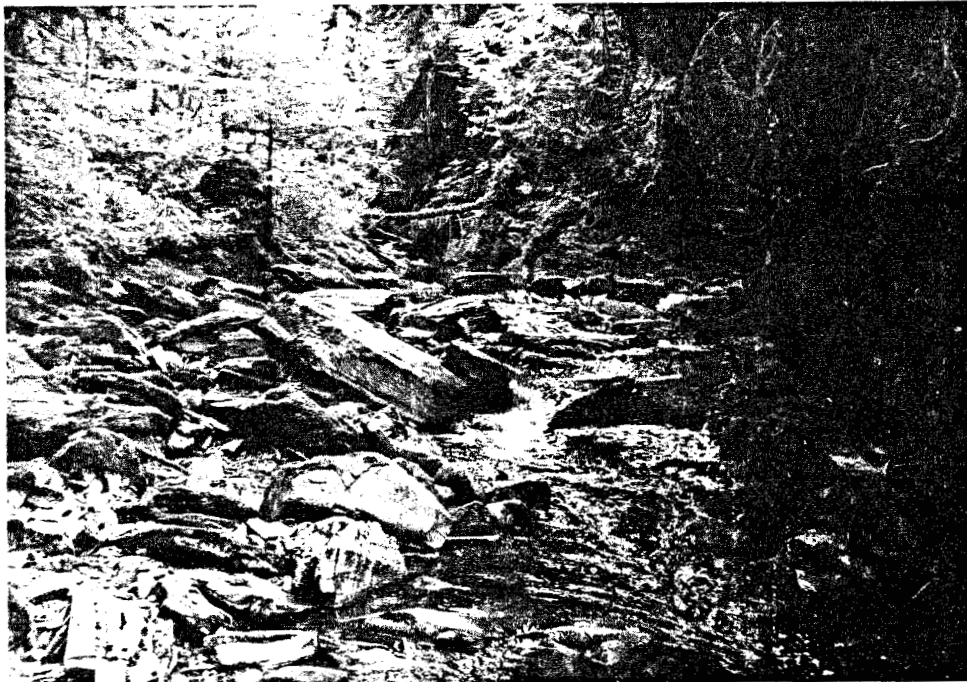
6. Section 4: Typical habitat above the falls.

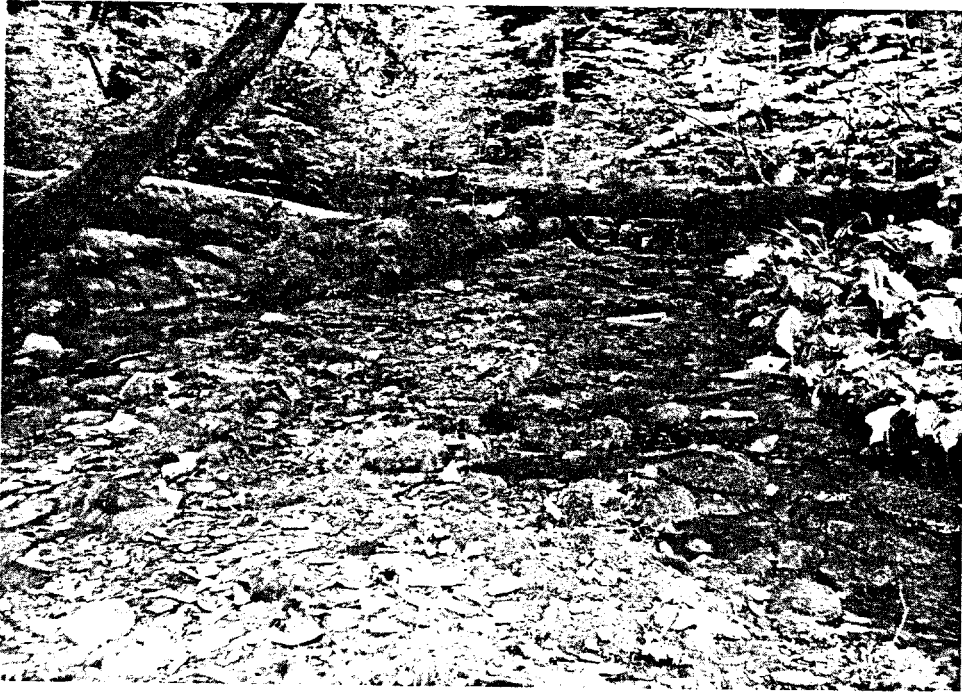
1. Section 1

Section 1: Many rearing coho were observed. The stream is very shallow and has a flow of only .03 m³/sec. The water temperature and pH are 9.5°C and 6.5 respectively. The substrate is predominately flat cobble.

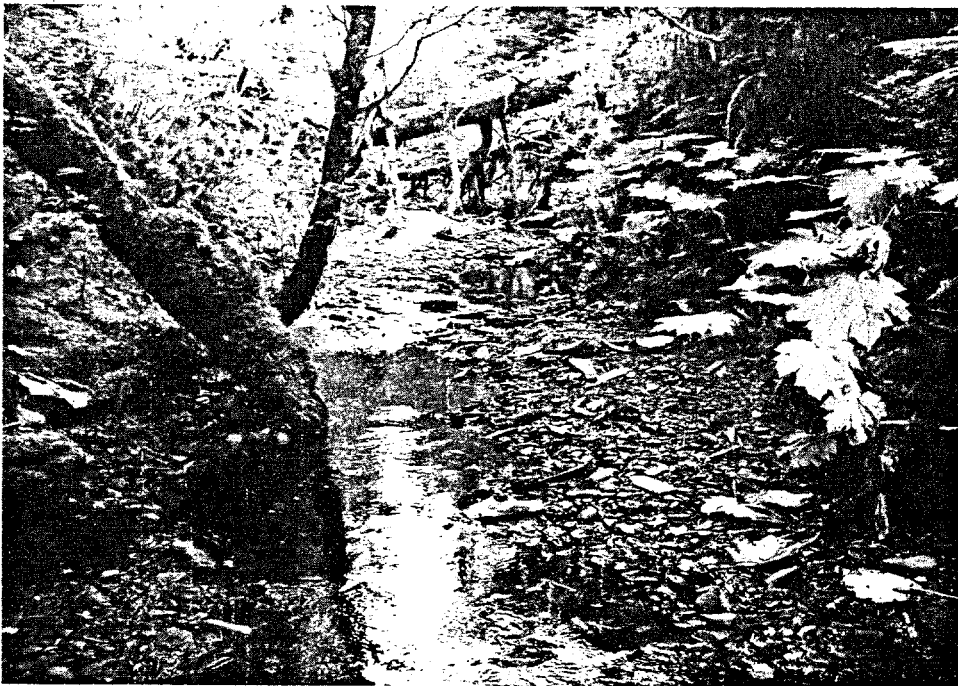
2. Section 3

Section 3: PS bones were abundant on the banks. Rearing coho were utilizing the undercut bank for rearing. Patches of blue clay were observed. The ASA is not exceptional quality due to the predominate flat cobble substrate and the shallow depth of the water.

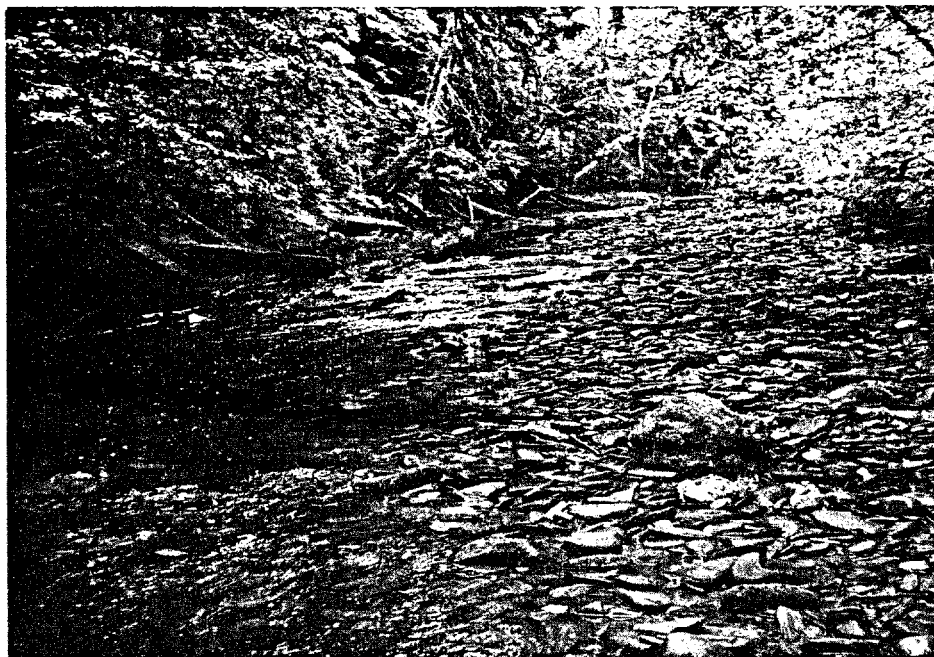
3. Section 2: Large flat cobble is found above the falls in Section 1.

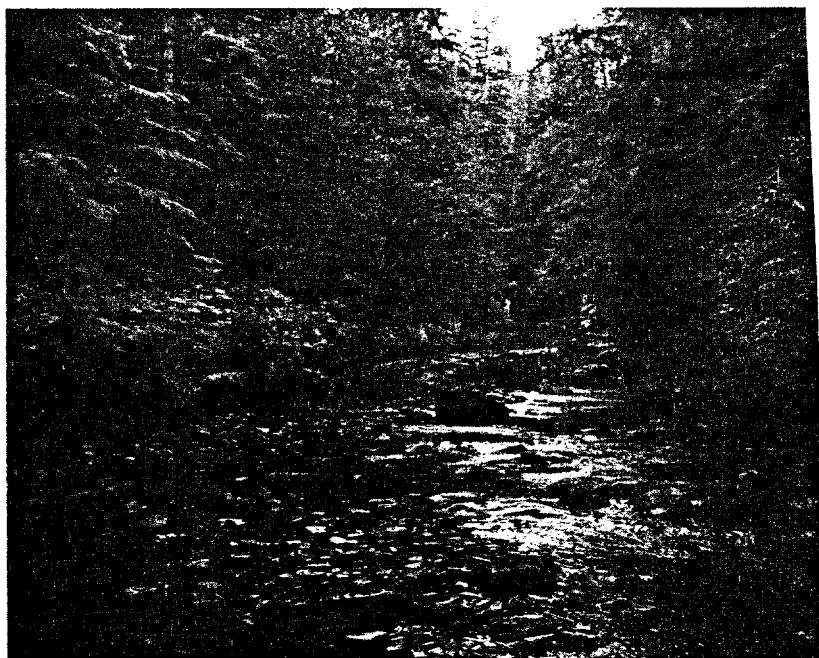
4. Habitat beyond a series of barrier falls in Section 4.

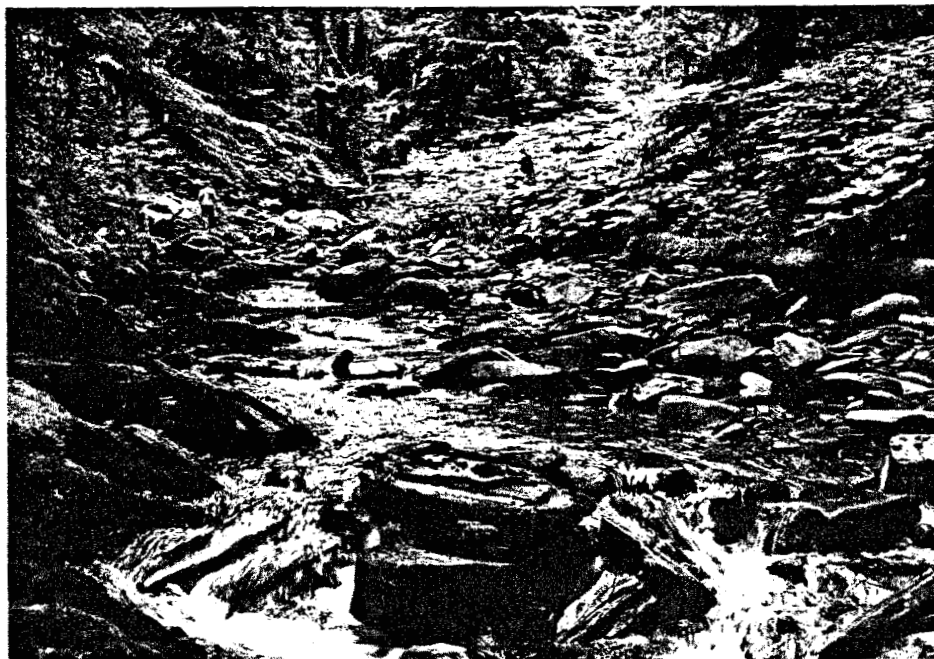
3. Section #5 End of survey. Steep gradient with a high proportion of boulder.

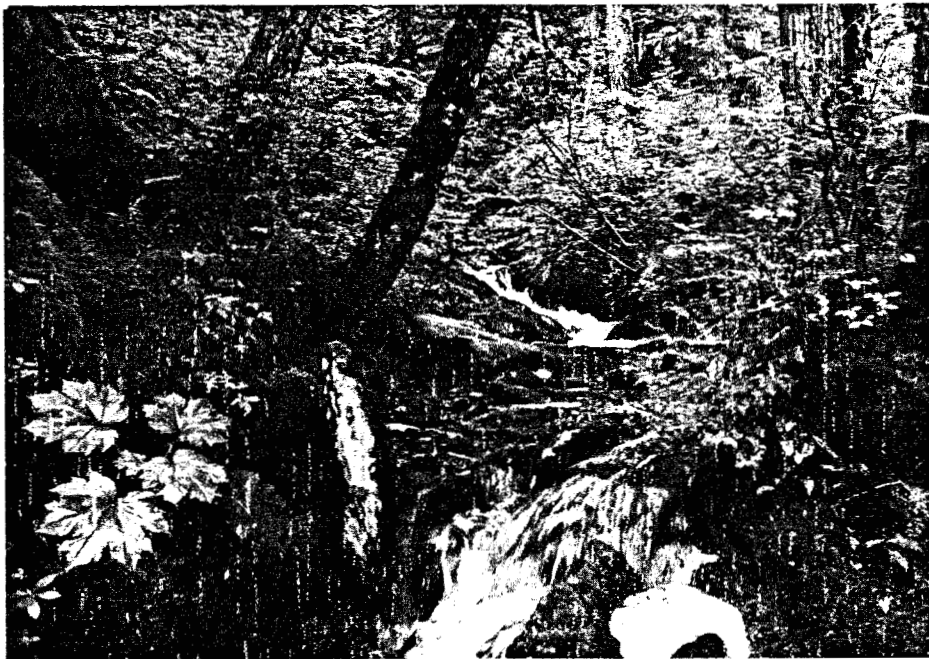
2. Typical poor habitat found below barrier falls.

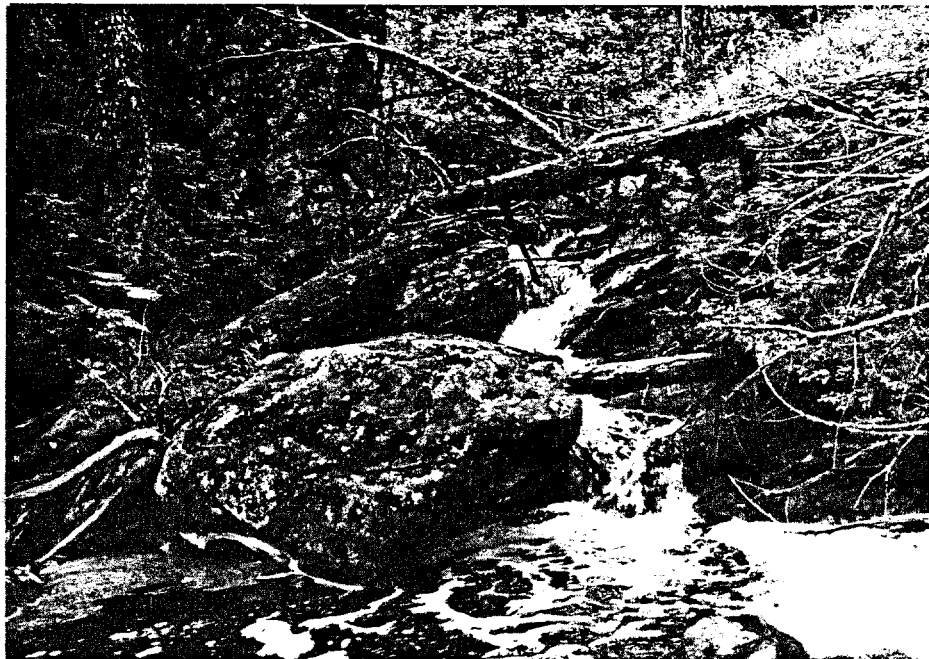
1. Section 1: Typical habitat found in Sections 1 and 2.

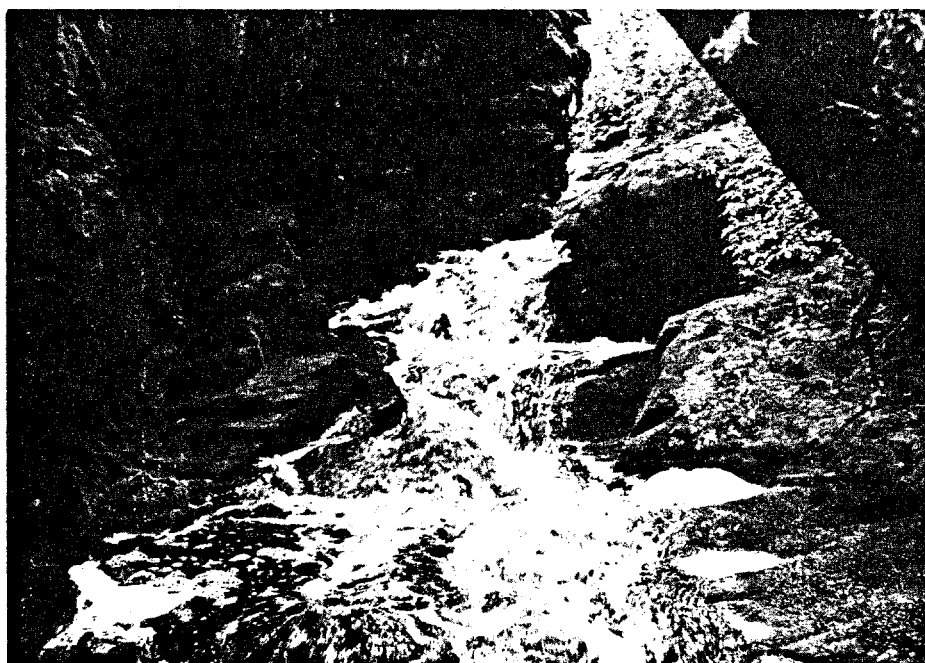
2. Possible velocity barrier in Section 2.

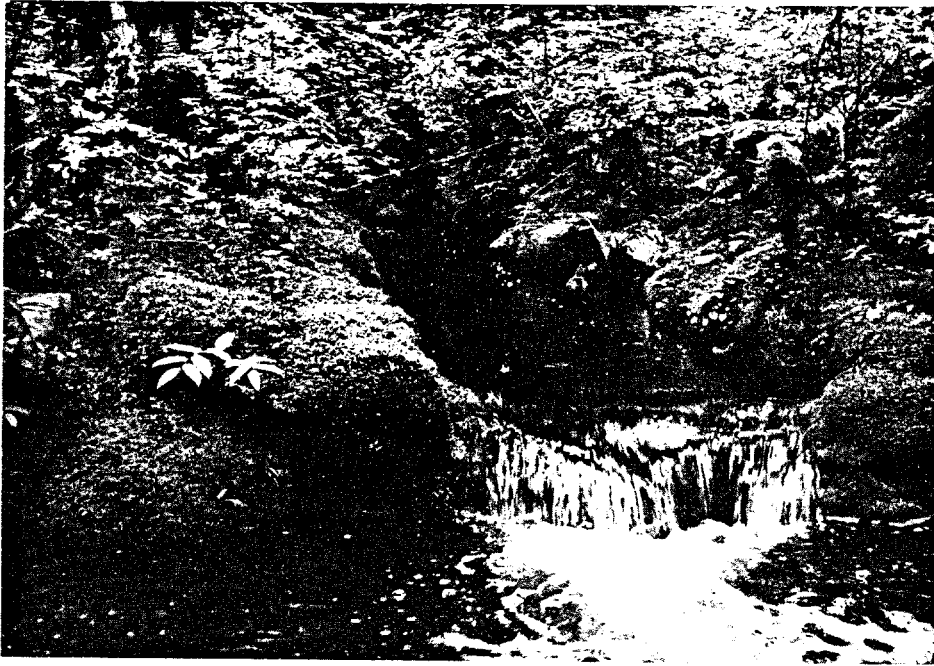
9. Section 2: Typical habitat found in Area B

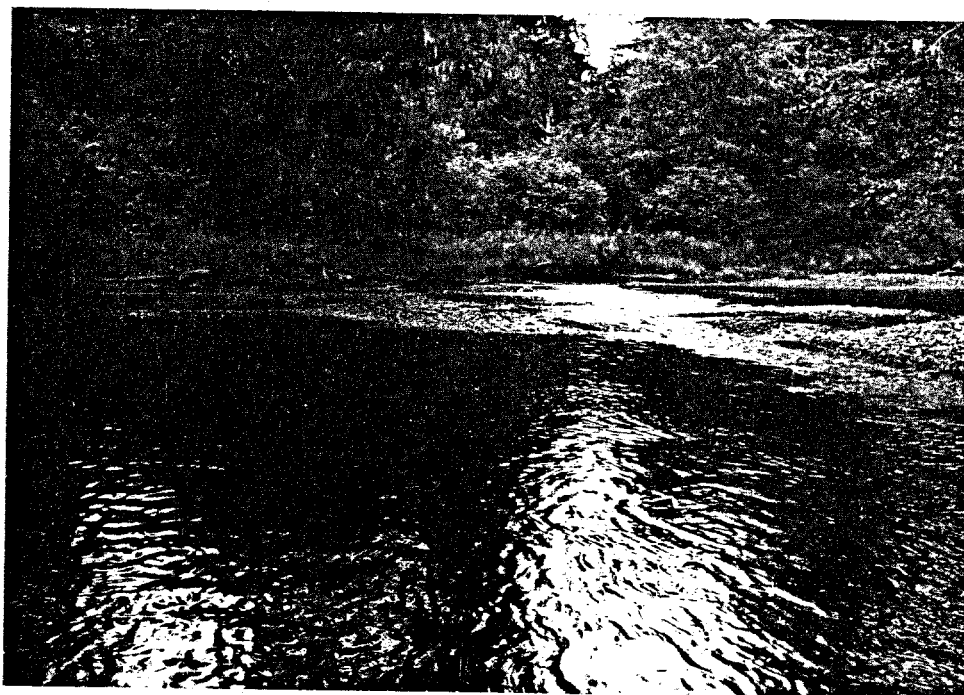
2. Section #9 First good riffle area.

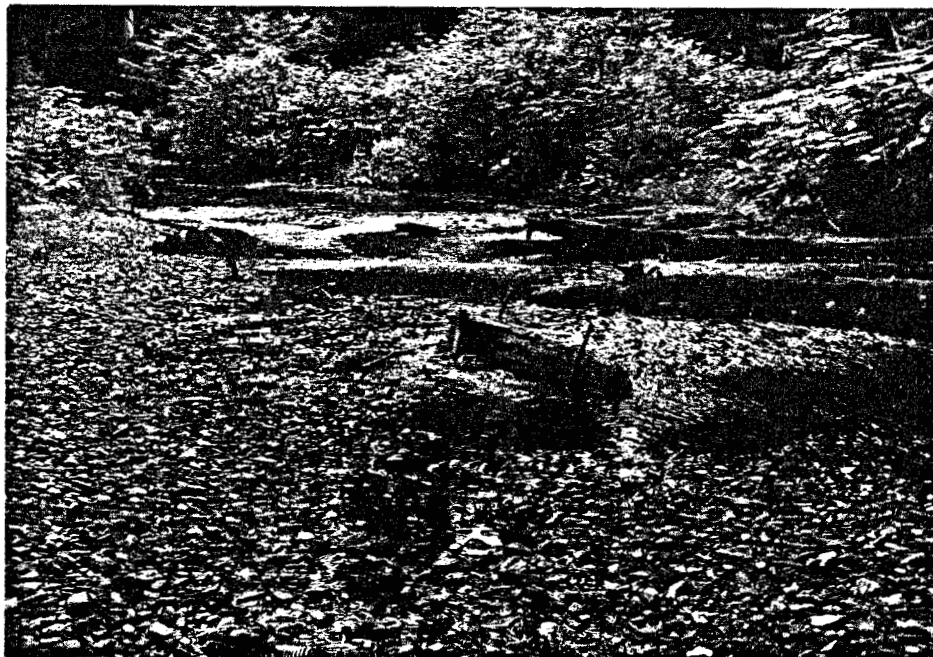
6. Excellent ASA in Section #15. Gravel is very loose.

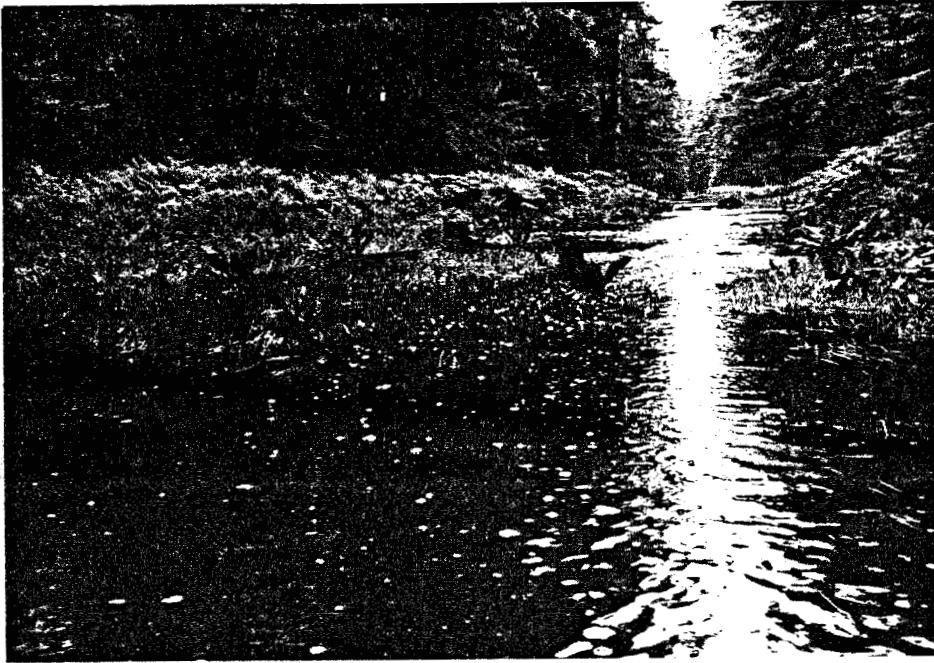
.5. Section 40: Grass and skunk cabbage were frequently observed growing in the streambed in the upper reach.

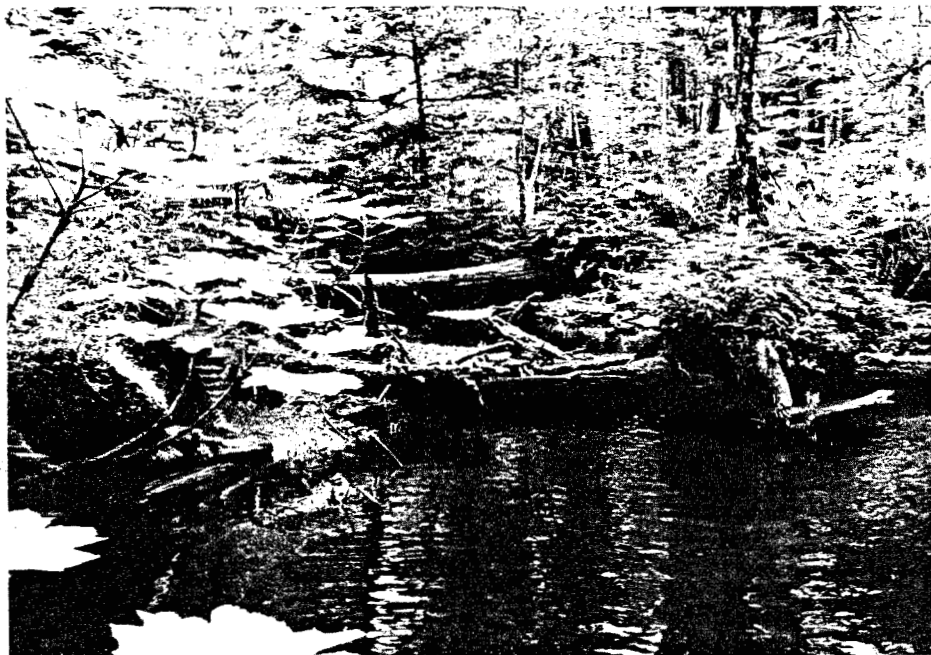
1. Section 4: Reach 1 continued good quality rearing habitat and ASA.

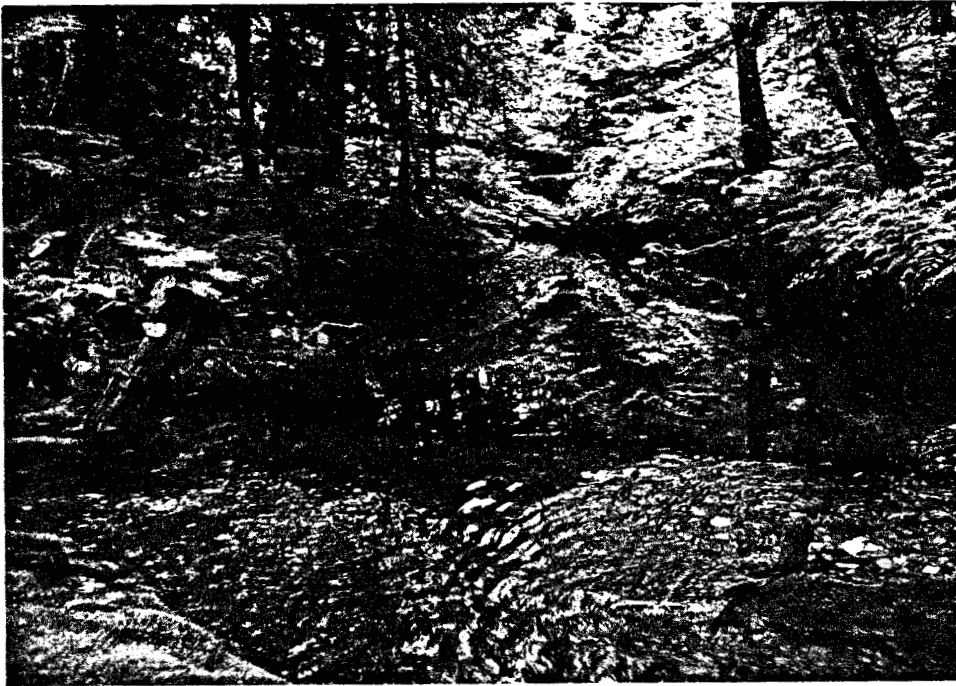
1. Section 2: Reach 1 contained good rearing habitat and ASA.

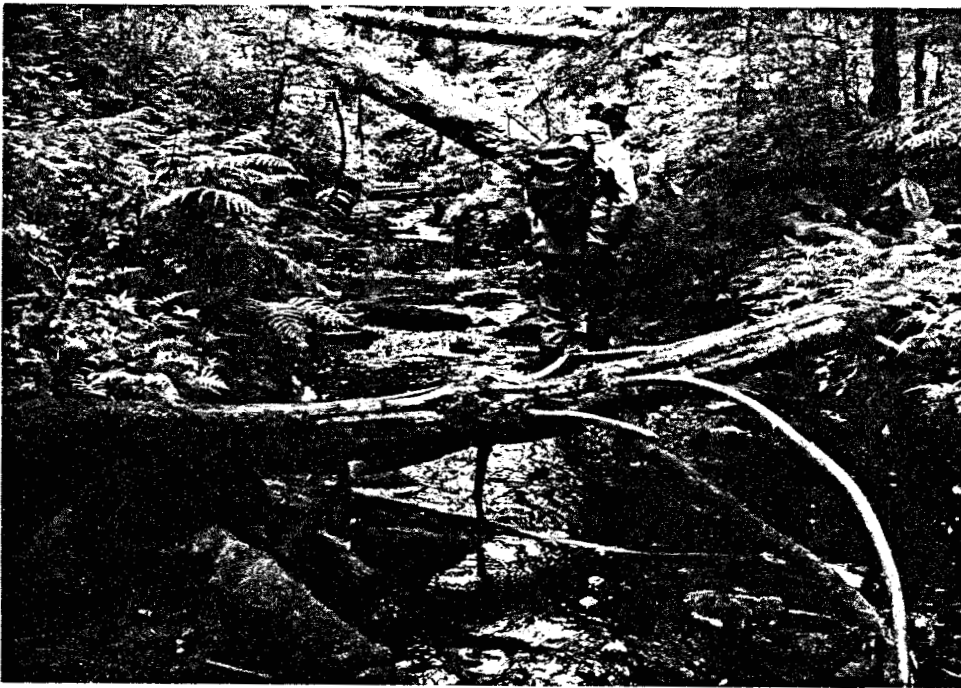
2. Reach 2: Contains lower quality ASA and rearing habitat.

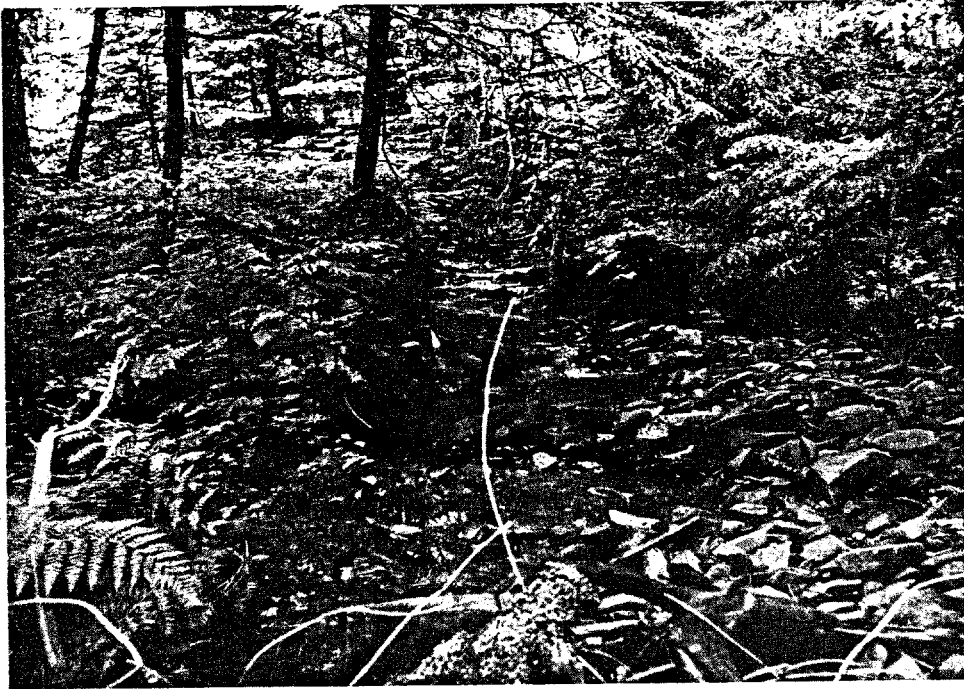
3. Only trout were observed above the beaver dam present in Section 21.

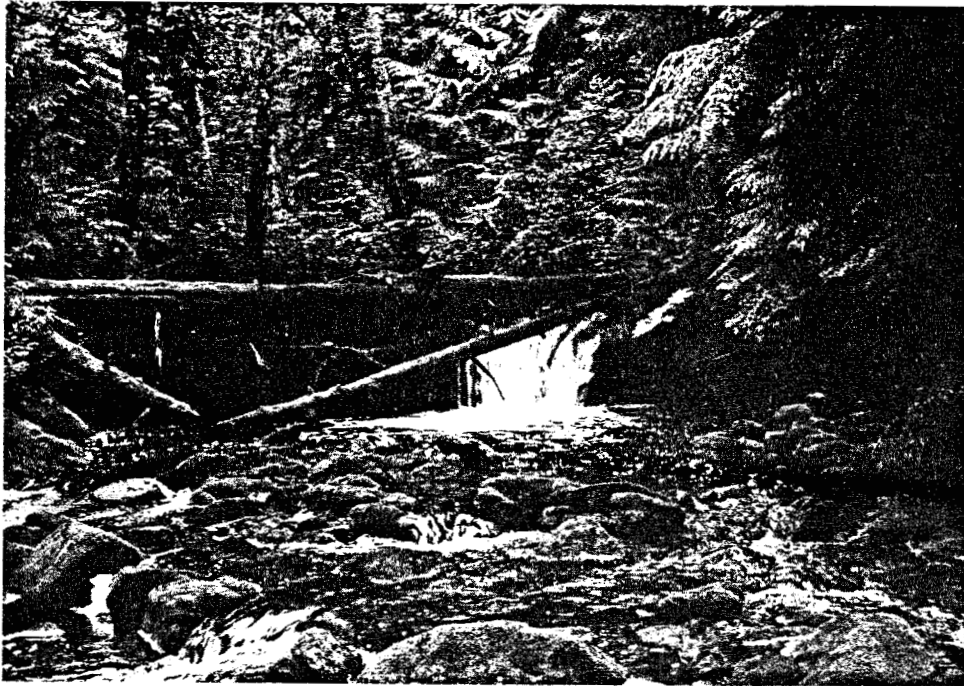
3. A possible PS barrier is present at the end of Section 3.

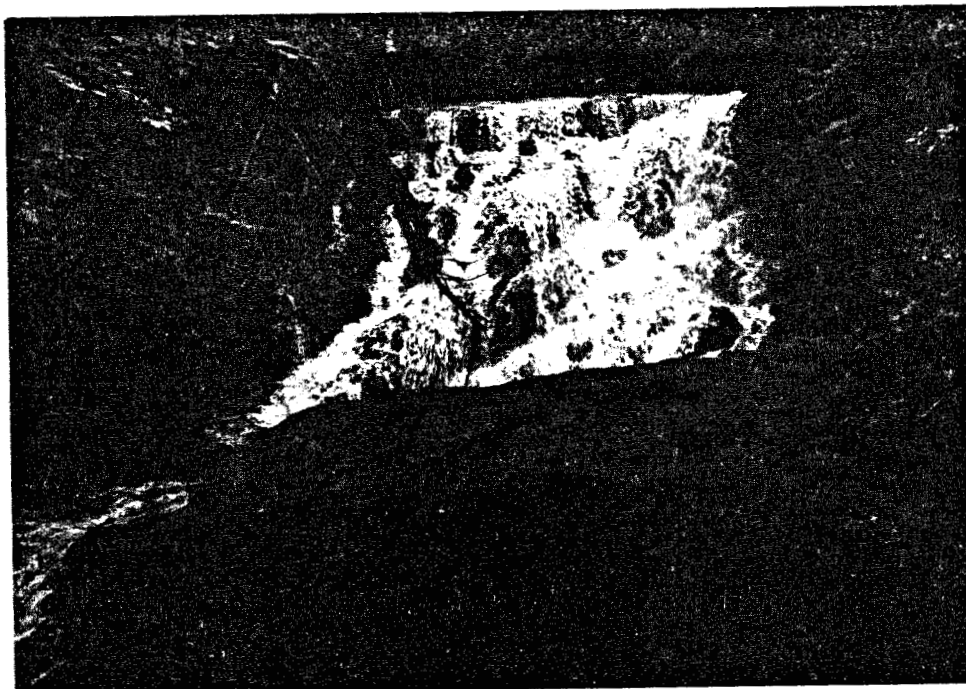
4. The survey areas was discontinued at a 6 m. barrier falls in Section 6.

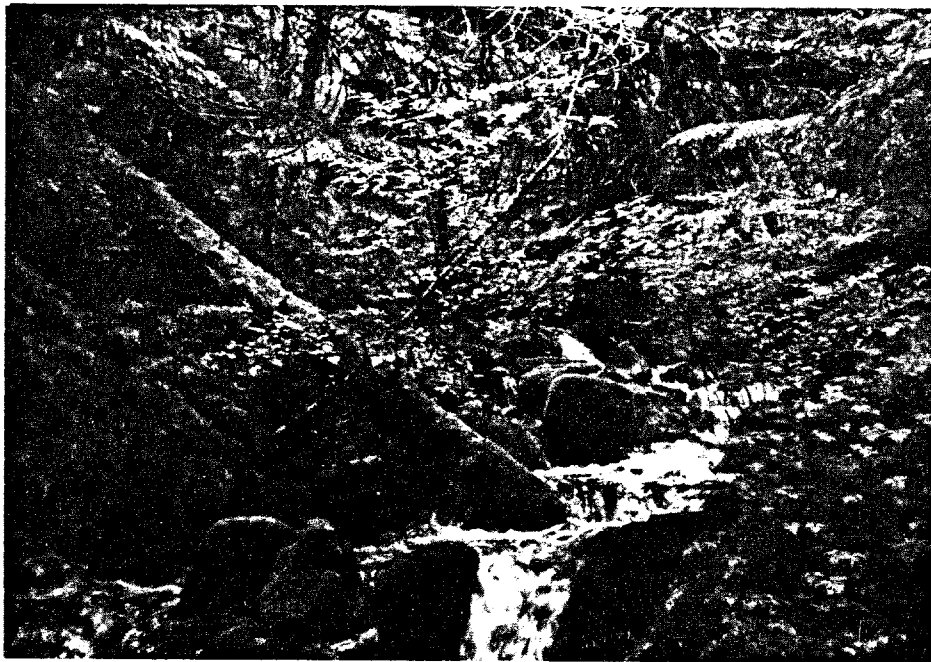
2. Typical habitat found in stream, 50 m. above ITZ.
The gradient is 20%

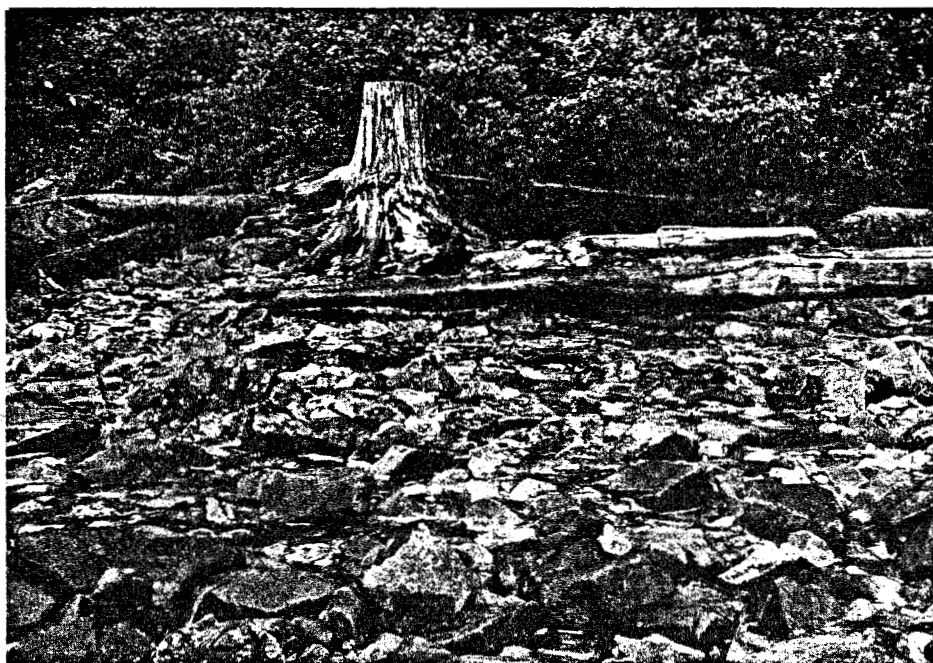
1. Large substrate found ITZ

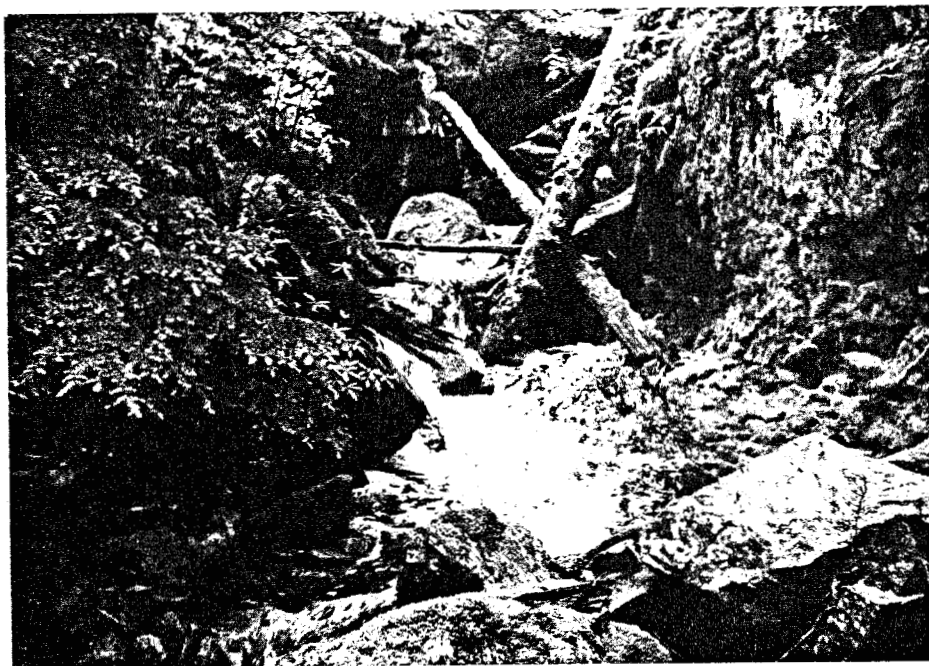
2. Habitat is 15 m. from the ITZ. A 4 m. barrier falls is just around the corner.
